RUBIDIUM AND CESIUM FREQUENCY STANDARDS
STATUS AND PERFORMANCE ON THE GPS PROGRAM
HARRY BETHKE, DALE RINGER AND M. VAN MELLE

Rockwell International
Satellite System Division
Seal Beach, California

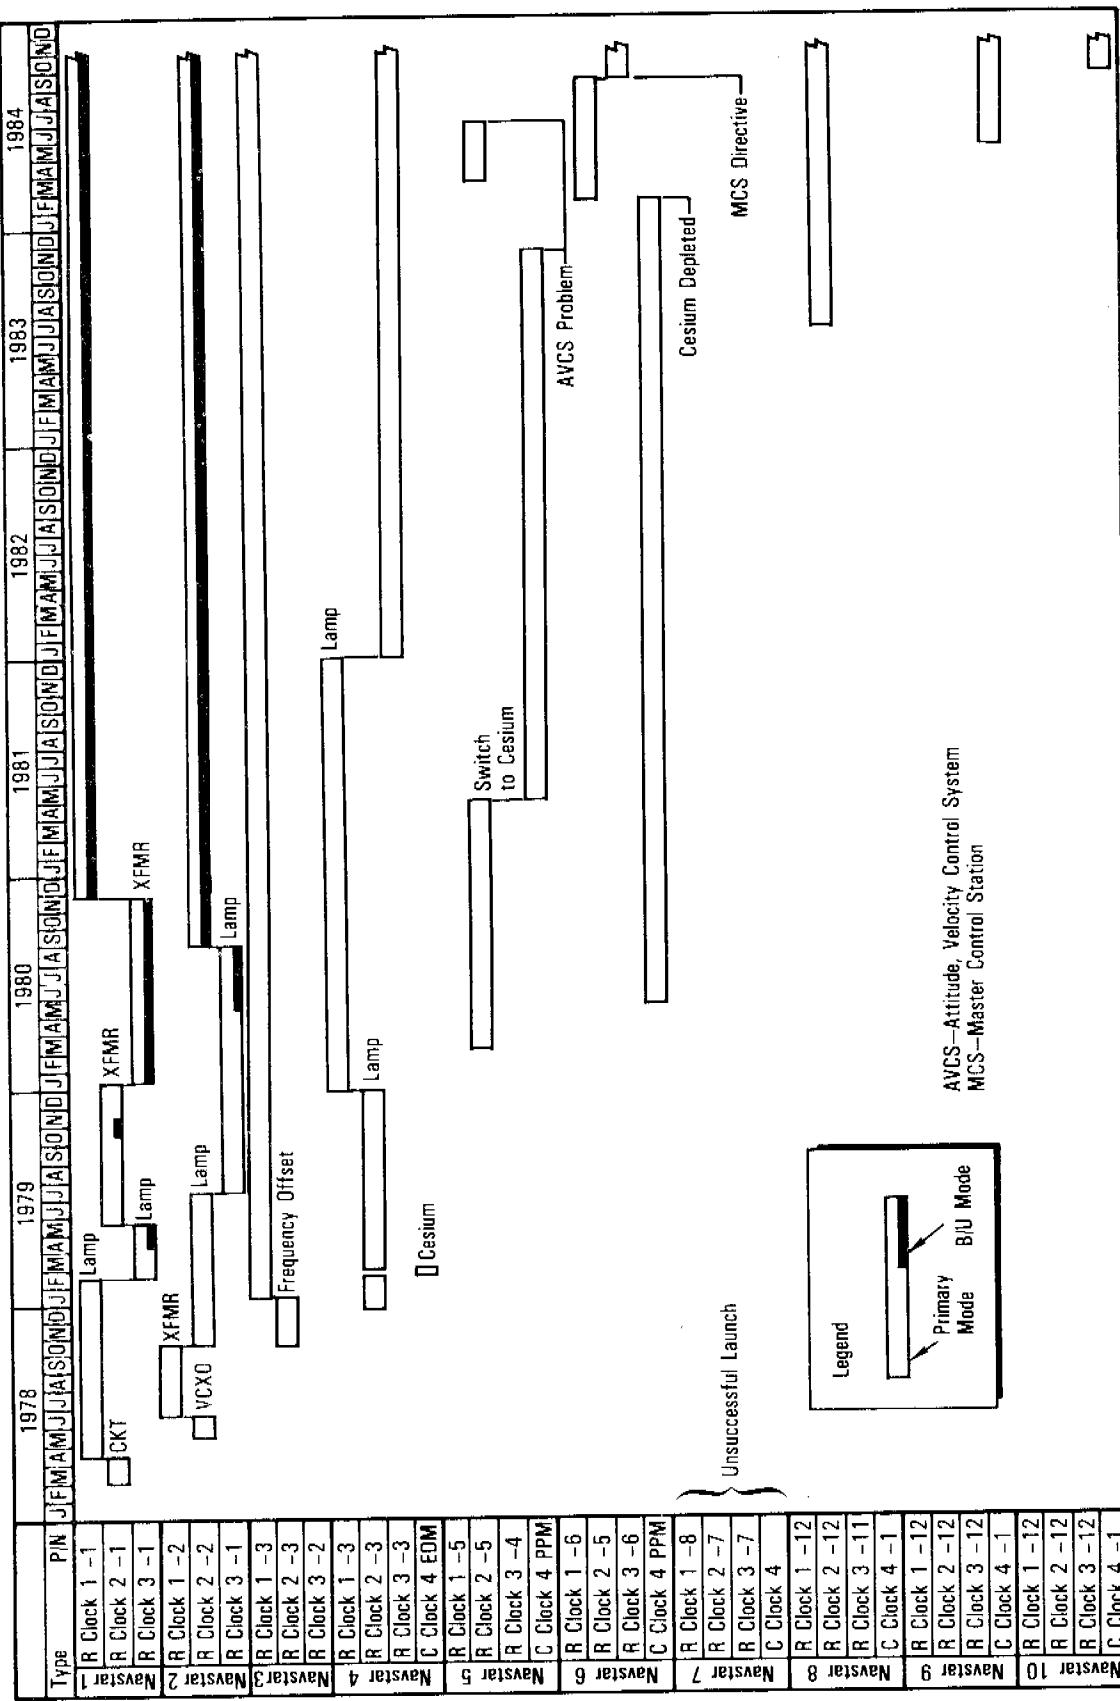
Figure 1. Navstar Clock Operating History

On-orbit operation data of GPS Rb frequency standards started with Navstar 1 in March, 1978, followed by Navstar 2 in May, 1978. The original Dash 001 part number clocks were used in Positions 1, 2, and 3 on Navstar 1 and in Positions 3 on Navstar 2. Dash 002 clocks were used in Positions 1 and 2 and Navstar 2. The only difference in the Dash 002 from the Dash 001 clocks was a time constant change in the servo control loop. As shown in Figure 1, three types of problems were experienced:

1. Power supply transformer failures
2. Lamp failures
3. Low frequency oscillation of the VXCO heater control

The new transformer was installed in all Dash 003 and subsequent clocks. Results of this change are very apparent from the data shown on Table 1. A total of 186 months (15.6 years) of on-orbit operation have accumulated with no transformer failures. Referring to Figure 1, note that Frequency Standard 1 on Navstar 3 has been operating continuously for 70 months (approximately six years); this provides a very high degree of confidence that the transformer problem has been corrected.

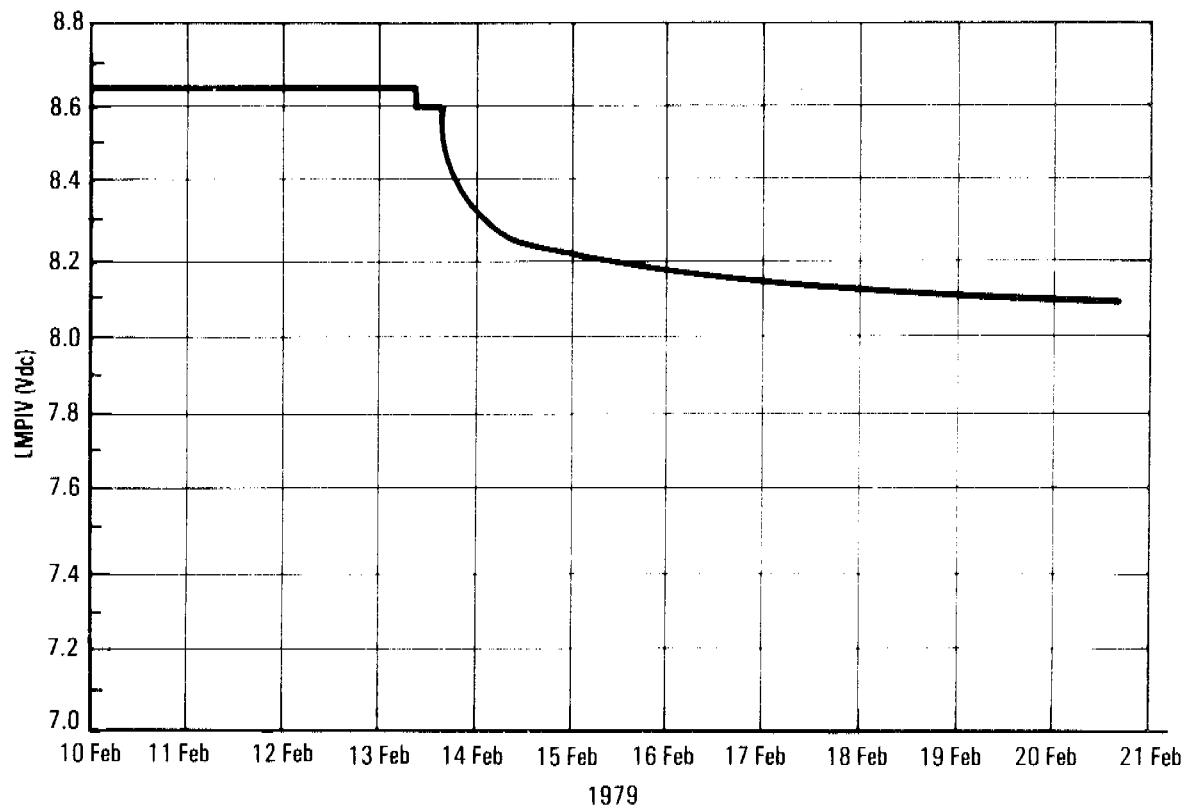
Figure 2. Navstar 1 Frequency Standard No. 1 LMPIV Anomaly

The Rb lamp failures were perhaps the most critical on-orbit problem encountered on the early space vehicles. To investigate the problem, a team was assembled that consisted of representatives from Rockwell, the National Bureau of Standards, Duke University, the USAF, Aerospace Corporation, and Efratom. Once the clock failure was established to be the lamp, a plan was initiated to duplicate the on-orbit failures in the laboratory. Lamps were prepared with an intentionally low Rb fill, installed into the physics packages, and subsequently installed into several frequency standards. Laboratory testing on these standards duplicated the on-orbit lamp failures. All units exhibited the same lamp voltage decay characteristics symbolic of the suspected lamp failures as illustrated in Figure 2.

To determine the amount of Rb in the lamps, a three-fold corrective plan of action was instituted:

1. For Rb lamps already built, the fill would be determined by neutron activation.
2. The fill of newly fabricated lamps would be determined by sampled destructive analysis.

3. A calorimetric measurement utilizing a differential scanning calorimeter is now used.

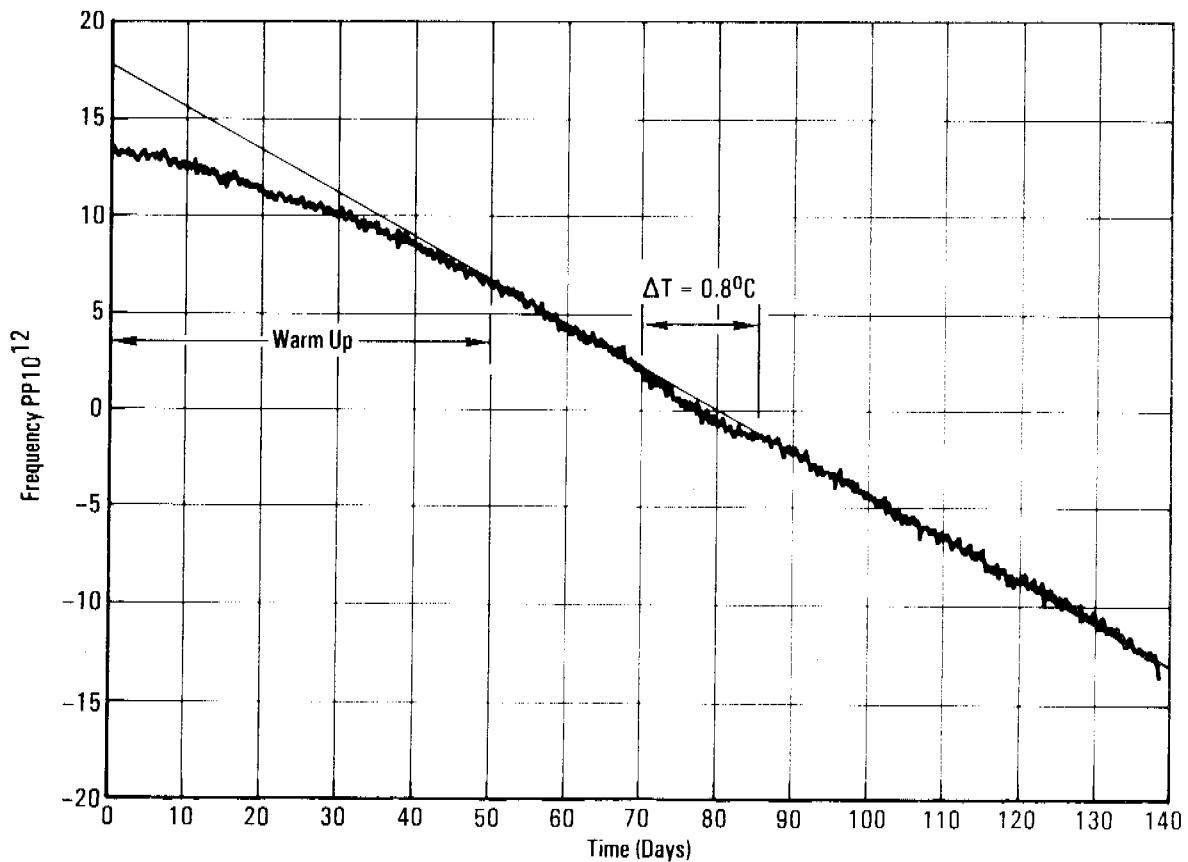
Figure 3. GPS 140-day Rb Stability Test

The beat frequency, $\Delta f/f$, is shown in Figure 3. The frequency was calculated from 1,000-second period average data, which was then averaged over 10 data points to conform to computer storage requirements. Examination of the entire 140-day period shows an initial "warmup" period of about 50 days, during which the drift changes from about $-6 \times 10^{-14} \Delta f/f/\text{day}$ to $-2 \times 10^{-13} \Delta f/f/\text{day}$. The frequency drift is relatively constant from Day 50 to Day 140, except for a dip from Day 70 to Day 86. This dip correlates to a drop in the clock baseplate temperature of about 0.8°C . This points out the critical role that temperature stability plays with frequency and time prediction error.

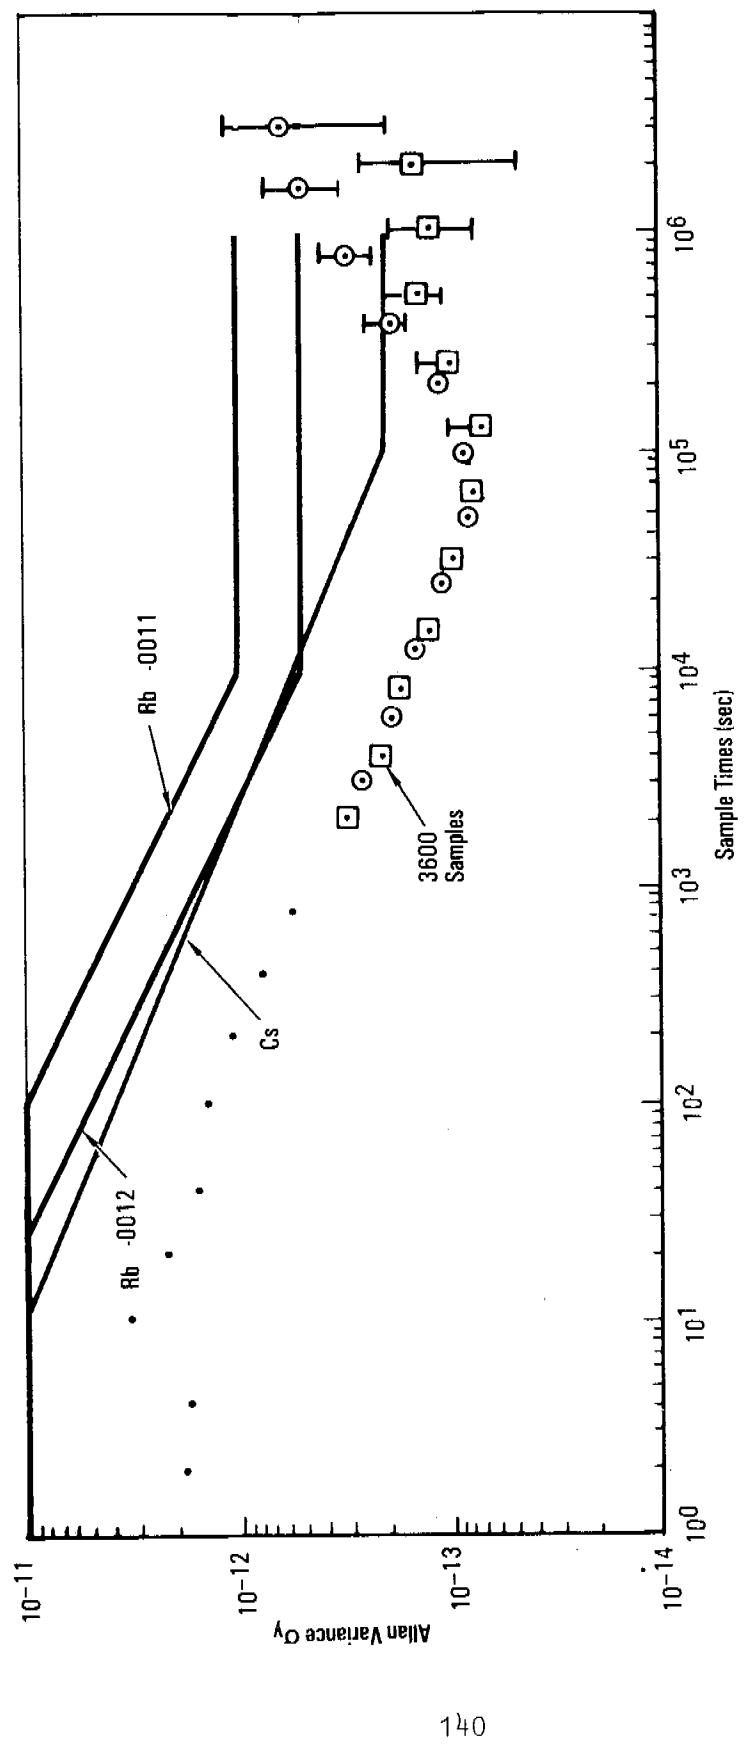
Figure 4. IR&D Time Error 140-day Stability Test Rb Frequency Standard No. LQX0001

The Allan variance, σ_y , can be calculated both with and without the warmup period data. It can be seen in Figure 4 that the main effect of the behavior is on the long-term values or the "random walk." The total data σ_y represents the usual RFS Allan variance signature; whereas, the day 50-150 σ_y values are better in terms of random walk. If μ is the slope of the random walk portion of the Allan variance plot where $\sigma_y \sim t^\mu$ for large t , then $\mu = 0.7$ for Day 0 to Day 140 data, and $\mu \approx 0.1$ for Day 50 to Day 140 data.

Excluding the data which was affected by the warmup or temperature change, the time prediction error is found to be very small. This points out the importance to the time error of small temperature changes to the RFS. Since the on-orbit Rb standards now have a baseplate temperature controller that controls the clock temperature to within $\pm 0.1^\circ\text{C}$, excellent time error values on orbit are expected as evidenced in Navstar 8.

It was seen from the baseplate temperature that a 0.8°C temperature plateau resulted in a small frequency shift. For a 15-day period, this gave a 600 to 700-nanosecond offset. This period influenced longer data length prediction intervals before, during, and after the occurrence of the plateau. All subsequent RFS's now are being controlled to $\pm 0.1^\circ\text{C}$ by a temperature controller.
